# DRMS PUBLICATIONS AND SCIENTIFIC MATERIAL

# IN SITU MECHANICAL CHARACTERIZATION OF THE MORTAR IN MASONRY BUILDINGS WITH DRMS

# DRILLING RESISTANCE: OVERVIEW AND OUTLOOK

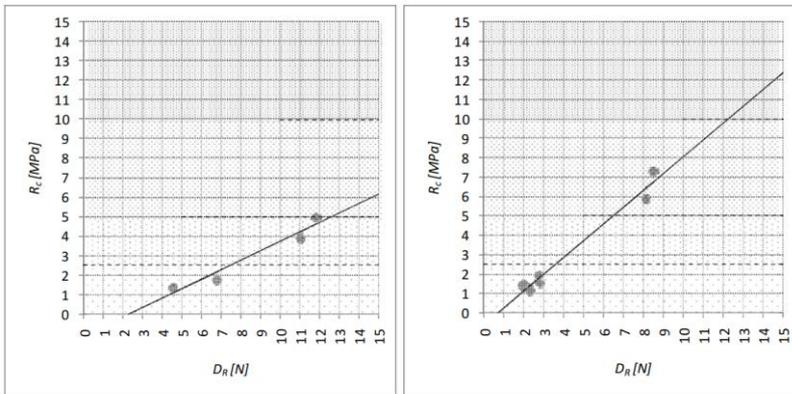
Figure 17 : curve of regression

$$R_c = - 1.107 + 0.483 DR \quad (1)$$

$$R_c = - 0.580 + 0.864 DR \quad (2)$$

where  $R_c$  is the **compressive strength** estimated by DR (drilling resistance). The Eq. (1) refers to drilling parameters  $v = 40$  mm/min e  $\omega = 100$  rpm, while the Eq. (2) is valid for  $v = 40$  mm/min e  $\omega = 300$  rpm.

The results of the regression analysis and the graphs  $R_c$  vs DR (Figure 17) and  $R_c(DR)$  vs  $R_c$  (Figure 18) show that the curves validated fit well to data and the errors on forecasting results about compressive strength are modest.

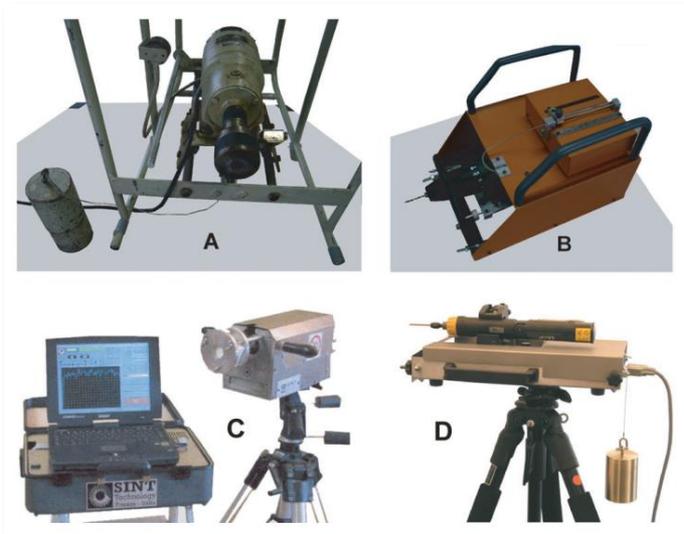
Drilling machines from the 60s to nowadays (photos A, B and D taken from Geotron-Elektronik, photo C taken from Sint Technology).

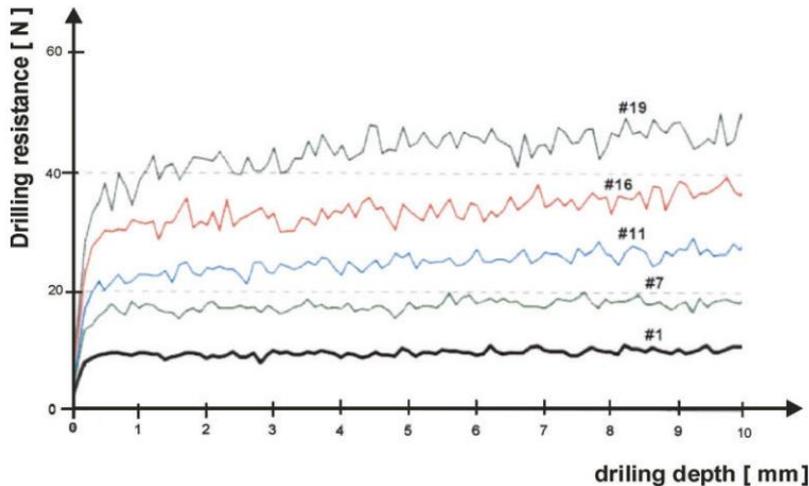
Increasing wear effect by drilling successive holes in an abrasive material (Sander sandstone), using a drill bit  $\phi$  5 mm at 600 rpm and 10 mm/min advancing rate

The wear effect is a major problem concerning abrasive stones measurements, because the drilling resistance increases during the tool working life even when drilling a more or less homogeneous material. Attempts to correct this effect are based on the assumption that the wear is constant and so an abrasion rate can be estimated. Calibration materials are used at the beginning and at regular intervals during the tool working life. Correction formulas are then applied to the measured drilling forces, based on the drilled length and resistance value of the first hole.

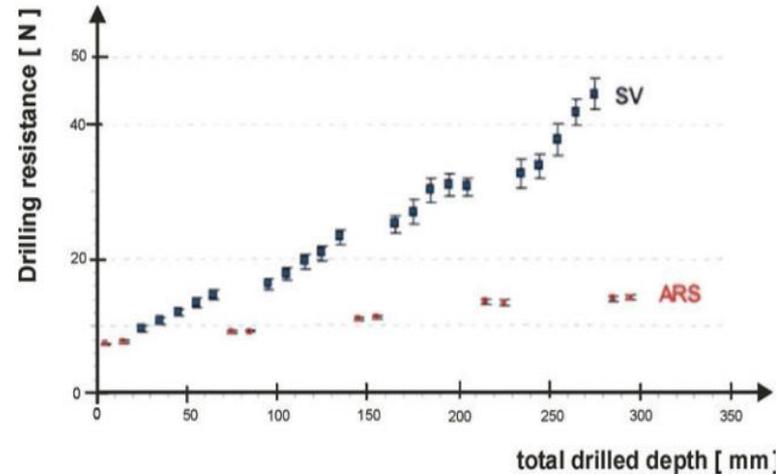
Differential abrasion increase of one drill bit  $\phi$  5 mm, measured on two materials with identical initial drilling resistance value. Total of 20 holes made on Sander sandstone (SV) and 10 holes made on artificial reference sample (ARS) under the same working conditions

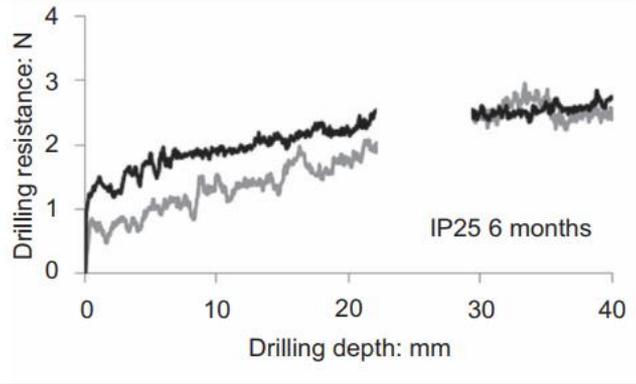
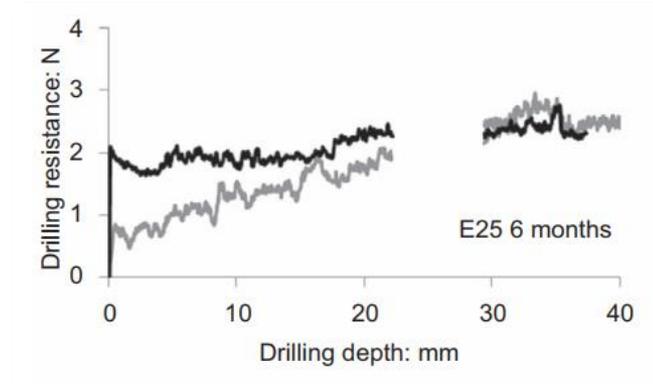
### Chilmark stone weathered

Grey line is untreated response

The drilling resistance measurement system successfully measured **changes in mechanical properties** with depth into the stone surface. Variations in the penetration force were attributed to both the effect of weathering, most notably by the hard crust on the Bath stone surface.

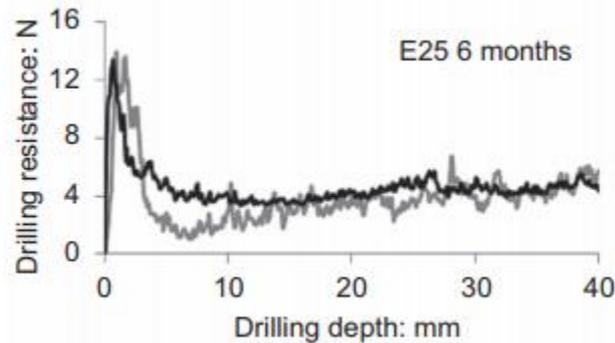
### Bath stone weathered

Grey line is untreated response

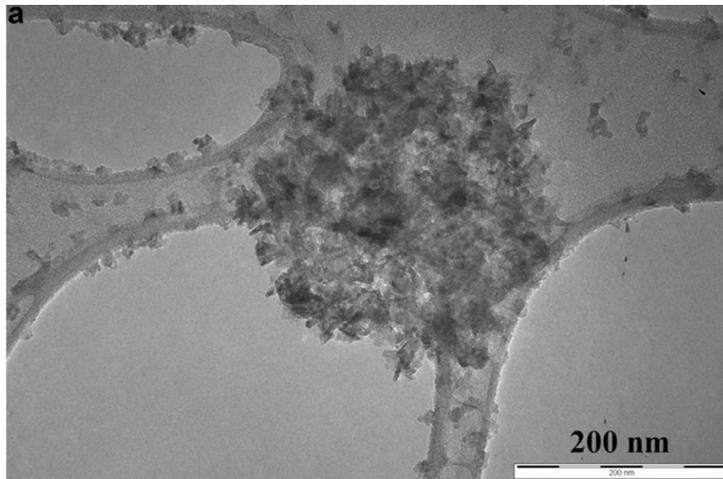
TEM micrograph of the nanolime sample

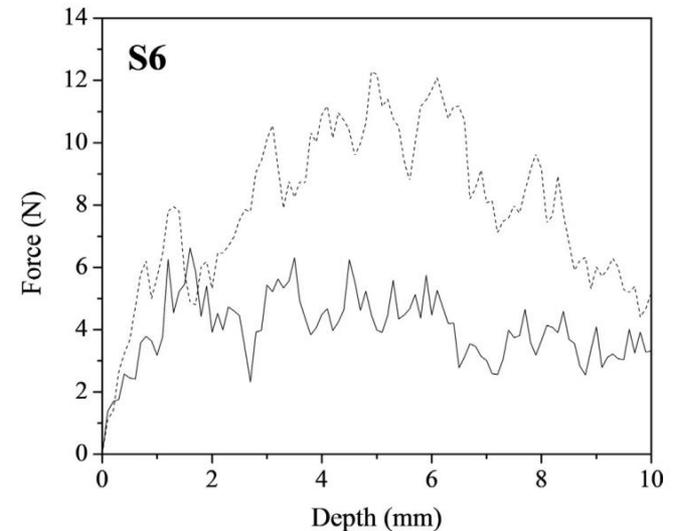
Drilling resistance profiles of untreated and treated (dotted line) biocalcarenite

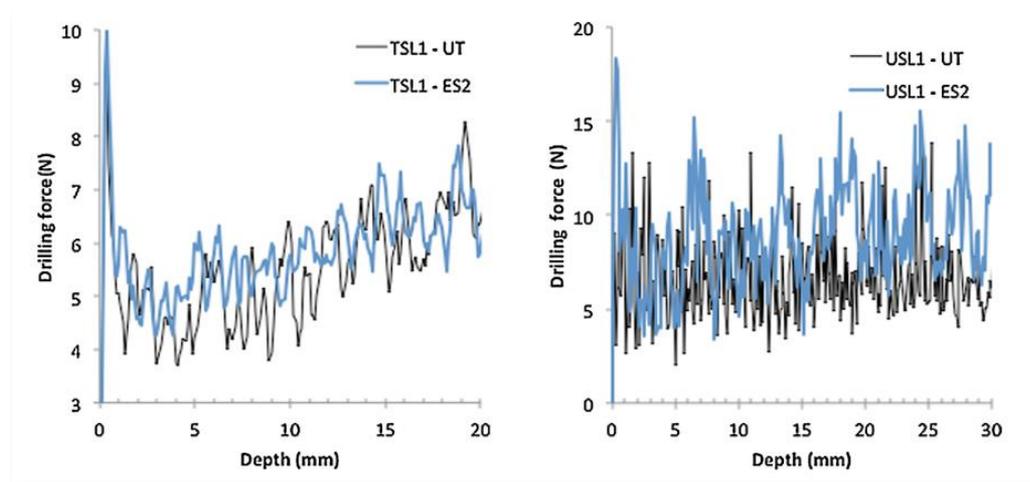
Finish-coat (TSL1) (left) and base-coat (USL1) (right) mortars treated with ES2.

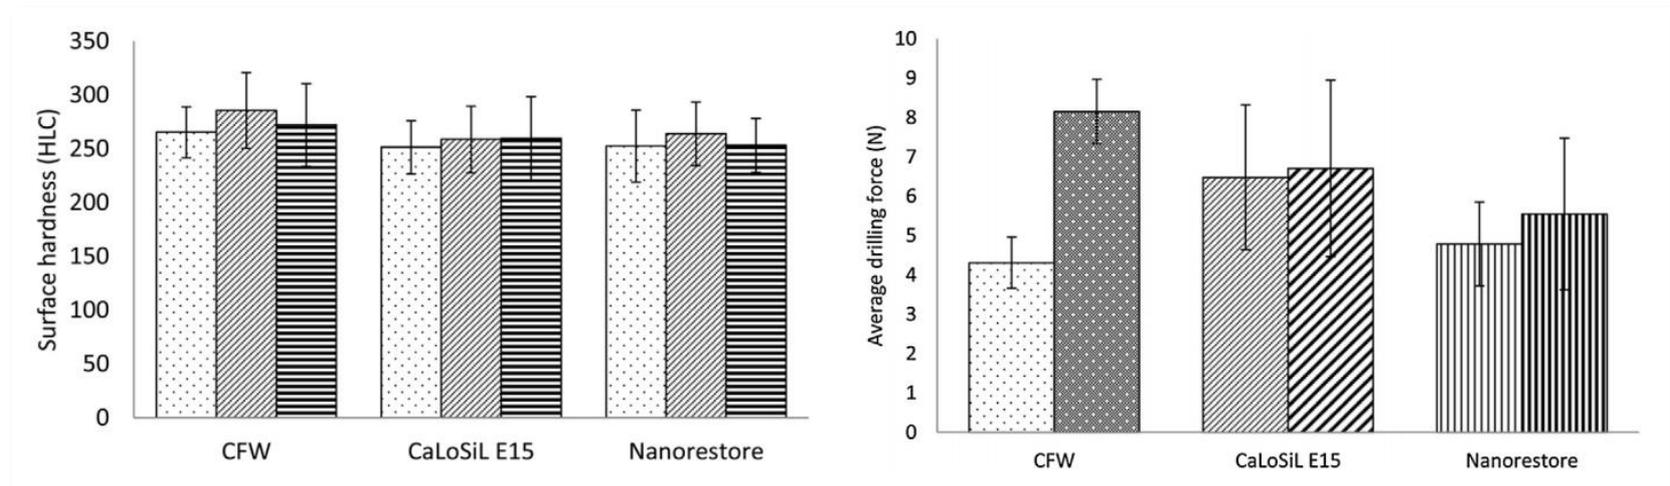
Hardness values measured before (dotted columns), 1 month (italic dashed columns) and 3 months (horizontally dashed columns) after the treatment with different consolidants

Average drilling-resistance force up to 8 mm in depth measured before (left column) and 3 months after consolidation (right column) with: CFW, CaLoSiL® E15 and Nanorestore®.

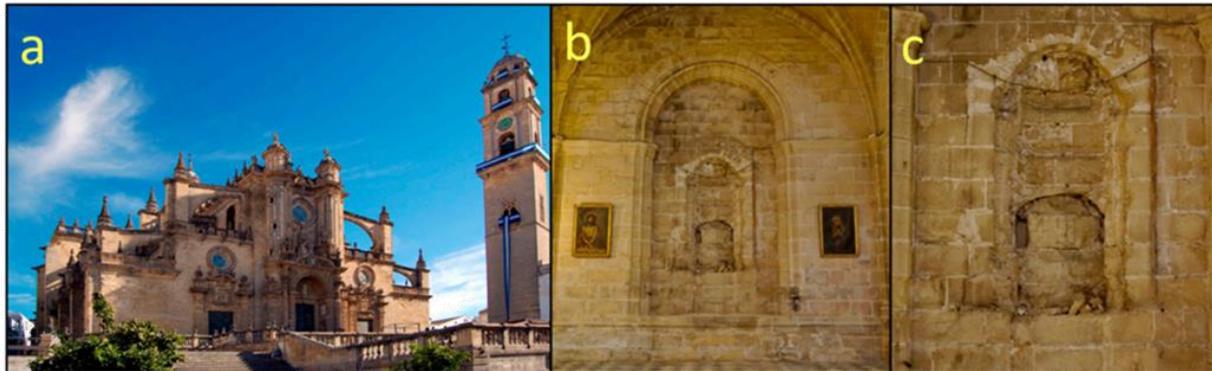
- (a) View of the main facade of the Cathedral of Jerez de la Frontera
- (b) Stone altarpiece of the Cathedral from which samples were obtained
- (c) Detail of the stone altarpiece affected by efflorescence, superficial detachments and sand disaggregation

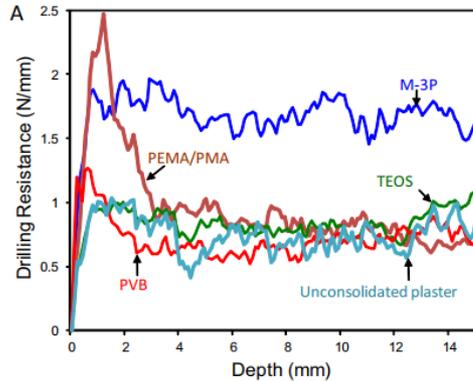
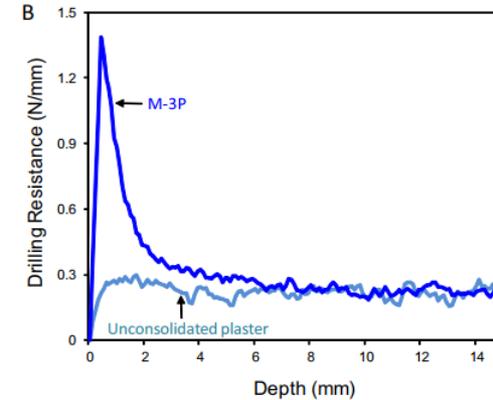
DR of gypsum plasters. (A) DR measured on gypsum plaster pieces with initial porosity of 29–38% treated with three conventional consolidants and M-3P culture medium. (B) DR of untreated and bacterially treated gypsum plaster with an initial porosity of 48%. Values are average of three to five drill holes.

DR curves of gypsum plasters before and after treatments application are shown in figure.

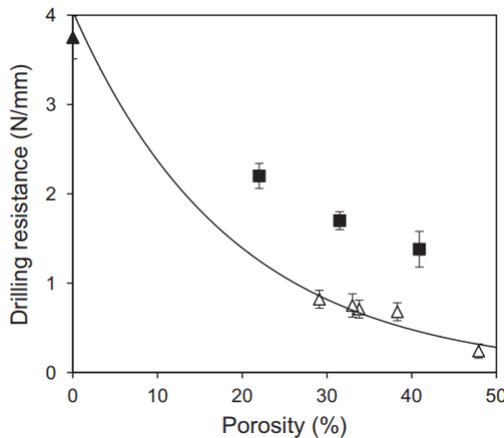
Variation of gypsum plasters DR vs. porosity.

The solid line shows the best fit to equation below for non-porous gypsum crystals (▲) and unconsolidated gypsum plasters (◇). DR values corresponding to bacterially consolidated gypsum plasters are also shown (■). Values represent the average of three to five drilling tests.

$$S = S_0 e^{-fP}$$

where S and S<sub>0</sub> are the strengths at porosity P and zero, respectively, and f is an empirical constant.
